Watershed Action Plan

Lake Elmore Watershed

Elmore, Vermont

November 30, 2020

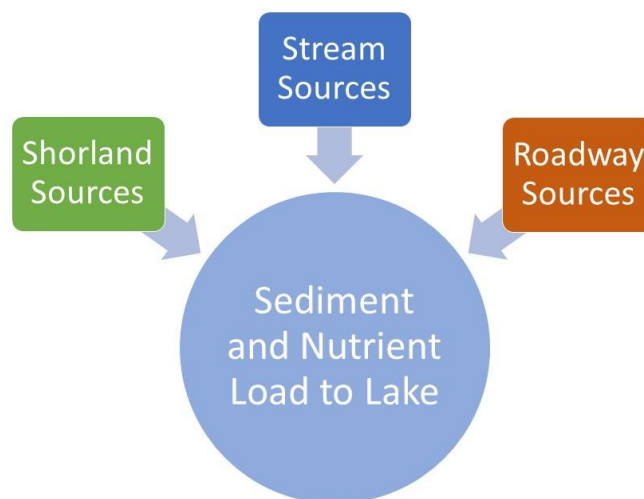
Figure 1: Conceptual diagram of primary water quality stressors on Lake Elmore.

The goal of the Lake Elmore Watershed Action Plan was to identify and evaluate water quality stressors to Lake Elmore, and to identify projects to mitigate inputs of sediments and nutrients. Environmental concerns and stressors identified by the group of stakeholders included channel erosion, road/ditch erosion, lakeshore encroachment, invasive species, soil erosion, nutrient loading, and thermal stress. The watershed assessment focused on the evaluation of the shoreland, tributary, and roadway sources of sediment and nutrients (Figure 1), as well as other concentrated sources of stormwater runoff in the watershed.

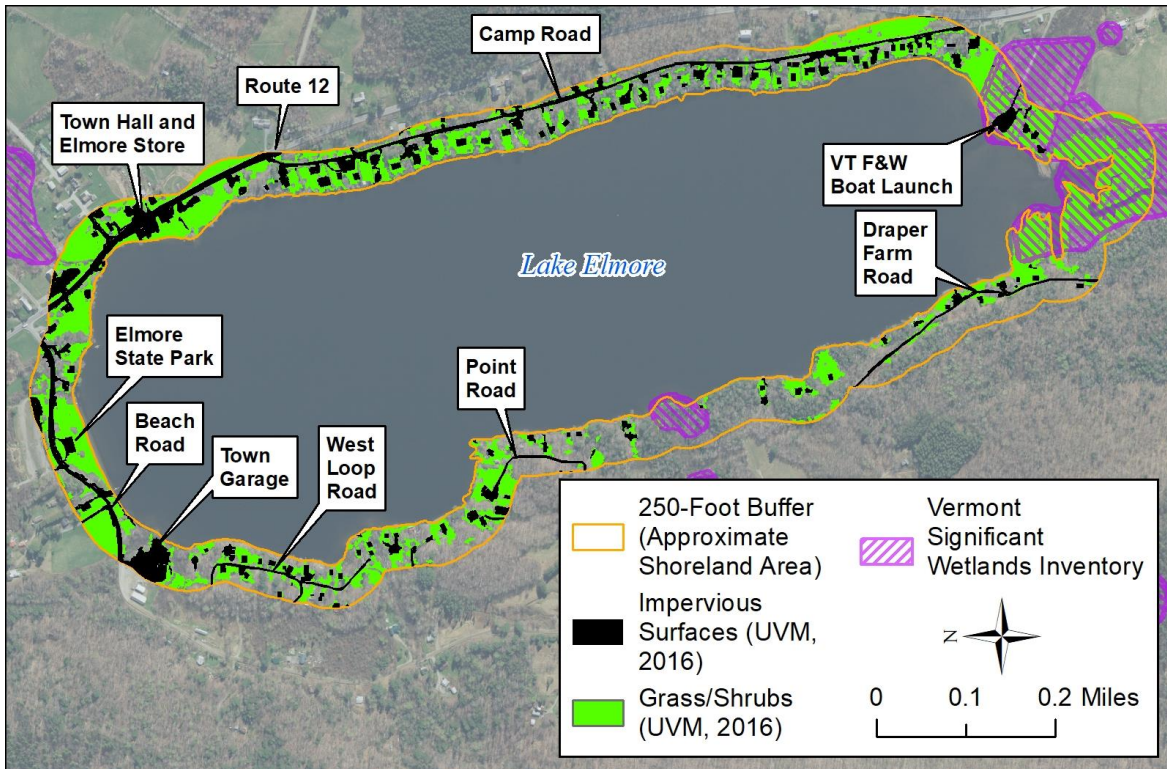
Figure 4: Shoreland land cover around Lake Elmore (UVM, 2016).

The Protected Shoreland Area defined by the VT DEC applies to land within 250’ feet of the mean water level of a lake greater than 10 acres in size (Figure 4). The shoreland zone around Lake Elmore has a relatively high level of development in the form of impervious surfaces (i.e., buildings, roads, and driveways) and developed pervious areas (i.e., lawns). Compared to other lakes where we have used the Watershed Action Plan/Stormwater Master Plan approach, Lake Elmore has the highest percentage of impervious surfaces and grass/shrubland based on the high resolution land cover and impervious mapping from UVM (2016). The grass/shrubland category includes wetland areas that may be naturalized, but even after accounting for these areas Lake Elmore still has the highest shoreland percent cover of grass of the lakes listed below (Table 3).

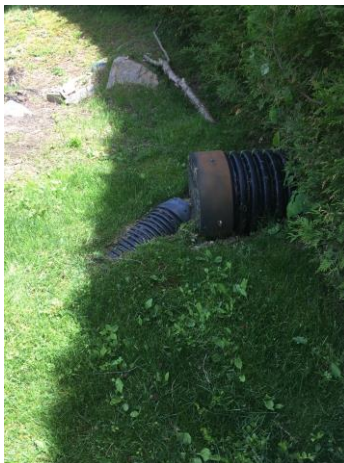
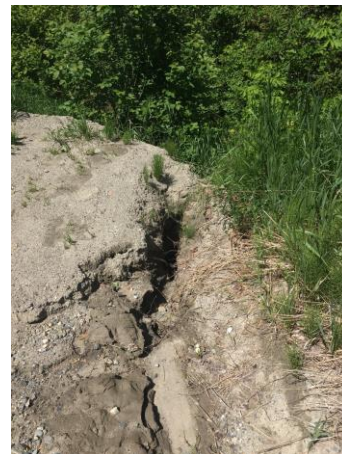
Figure 5: A culvert on private property with reduced capacity compared to the road cross culvert received the lowest problem area score (left photo, Project SW-11). Erosion and transport of sediment Lacasse Road directly to a stream received the highest problem area score (right photo, Project SW-28).

3. **Project SW-28: Lacasse Road** – Erosion along the road shoulder due to the lack of ditches to convey flow has caused a significant pile of sediment to accumulate next to the stream with gully erosion through the pile to the stream. Sediment deposition and a flowpath to the stream is visible on the downstream side of the culvert as well.

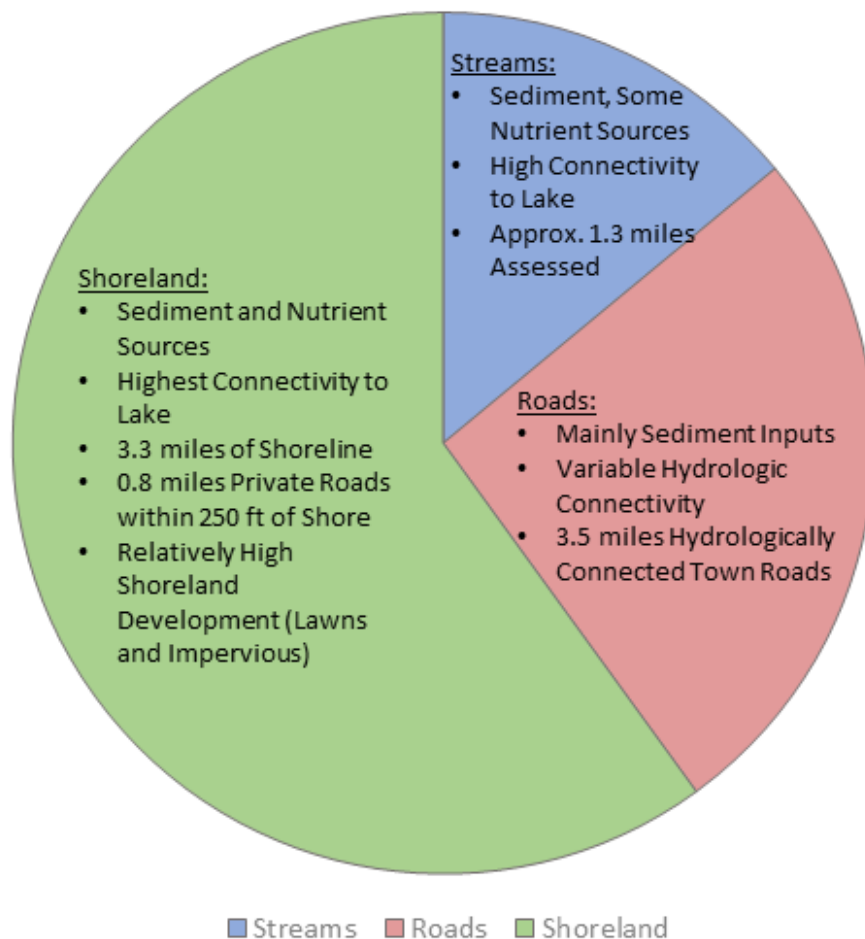
Figure 6: Relative contribution of sediment/nutrients to Lake Elmore from various sources.

Based on the distribution of project types, as well as each project’s watershed location, size, and existing nutrient/sediment load, we estimated the relative load from each of the primary “sectors” of the Lake Elmore watershed. Given the high degree of development along much the lake’s shoreline, as well as the extensive network of private gravel roads and driveways near the lakeshore, it is our opinion that the lakeshore represents the largest contribution of sediment and nutrients to the Lake. Municipal roadways and associated drainage from roadways likely represent around one third of the load, while stream bed and bank erosion appears to represent less than one quarter of the load (Figure 6).

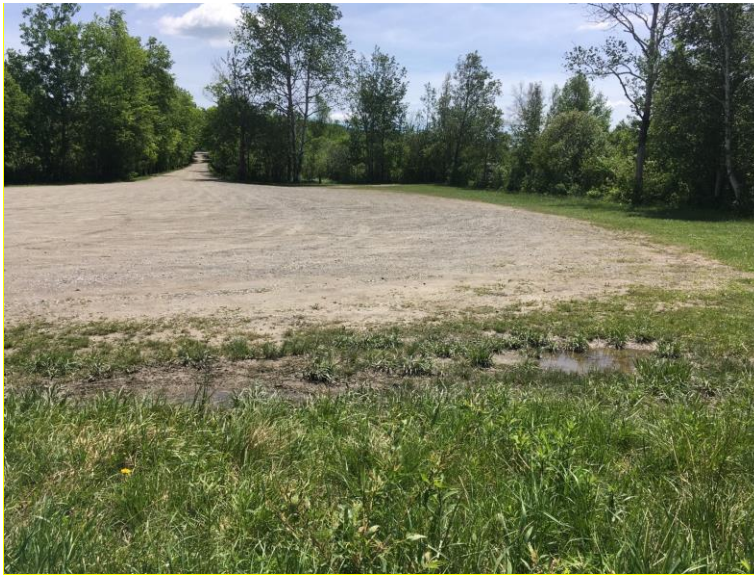
Figure 7: Gravel parking area at the VT Fish & Wildlife Boat Launch.

grass along the margins of the parking lot and overflow directly into the lake. Along the shoreline, wave action is eroding an area vegetated with mowed grass.

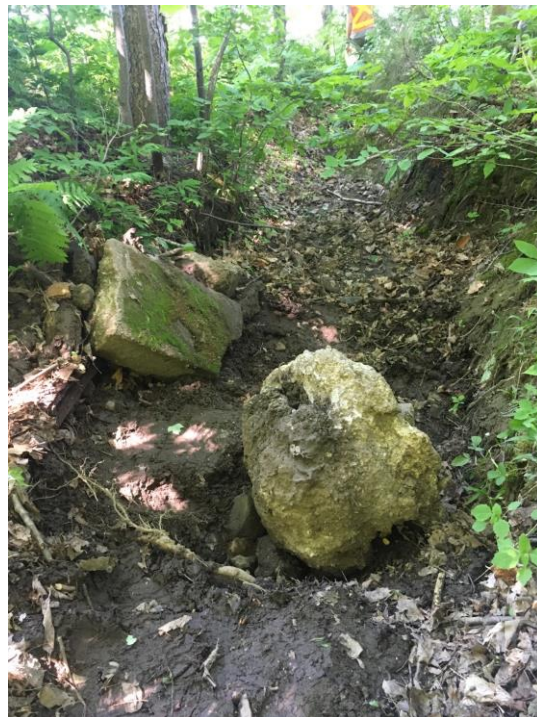
Figure 8: Erosion in the swale downstream of Camp Road. The concept design for this area (SW-5) describes BMPs that would stabilize erosion and treat runoff.

1. **Project SW-5: Camp Road Swale** – There is erosion at the 15” culvert outlet and in the swale near the lake confluence. The swale emerging from an 18” HDPE culvert upslope of the road is steep, contributing to erosive flow velocities downstream.
2. **Projects SW-13 & L-3: Vermont Fish and Wildlife Boat Launch** – Runoff from the gravel parking lot pools in low spots on either side of the boat launch. The low areas are vegetated with mowed
